isolating inflow & infiltration

Sanitary district utilizes flow monitoring data to eliminate backup events

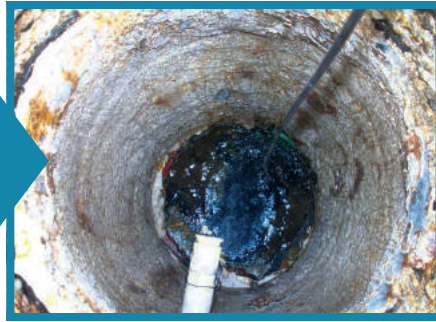
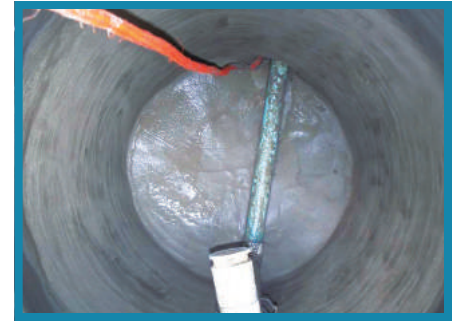
Left: Damaged manhole before rehabilitation work; Right: Manhole after repair

DCSD replaced the lids on 500 manholes with sealed and locked lids. Manholes with severe cracks and holes were lined with cement. DCSD sent notification letters to homeowners when root intrusion or cracks were found in lateral lines to prevent backups from occurring. Homeowners were pleased with DCSD for its proactive efforts.

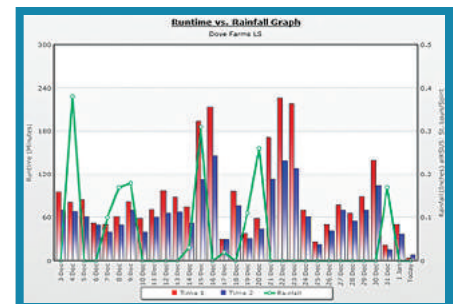
The Runtime vs. Rainfall graph shows that spikes in rainfall (green line) caused pump runtimes (red and blue bars) to increase.

Arbuckle began the sewer system investigation by observing the Runtime vs. Rainfall report. “When we had a significant rain event, I looked at the data and it indicated that we had more inflow than infiltration because peak flow occurred directly after a rain event. We had to battle infiltration, but it wasn’t as bad as the inflow,” Arbuckle said. The report helped Arbuckle identify problem areas by determining where to place video cameras along the trunk and lateral lines. Video inspection unveiled multiple cracked pipes and root intrusion. The data from the Runtime vs. Rainfall report and video inspection were used to plot locations on district maps that were urgently in need of repair. A green line displayed the rainfall, while red and blue bars displayed the pump run times.
